**National Highway
Traffic Safety
Administration**

Case Vehicle (A): 1999 Chevrolet
 Type: Cavalier, 4-door sedan
 Driver: 28-year-old male
 CDC: 12-FCEN-1, 12-LZES-1, 12-FZEN-2

Case No.: 212-00
Veh. (A): 1999 Chevrolet
Type: Cavalier, 4-door sedan
Driver: 28-year-old male

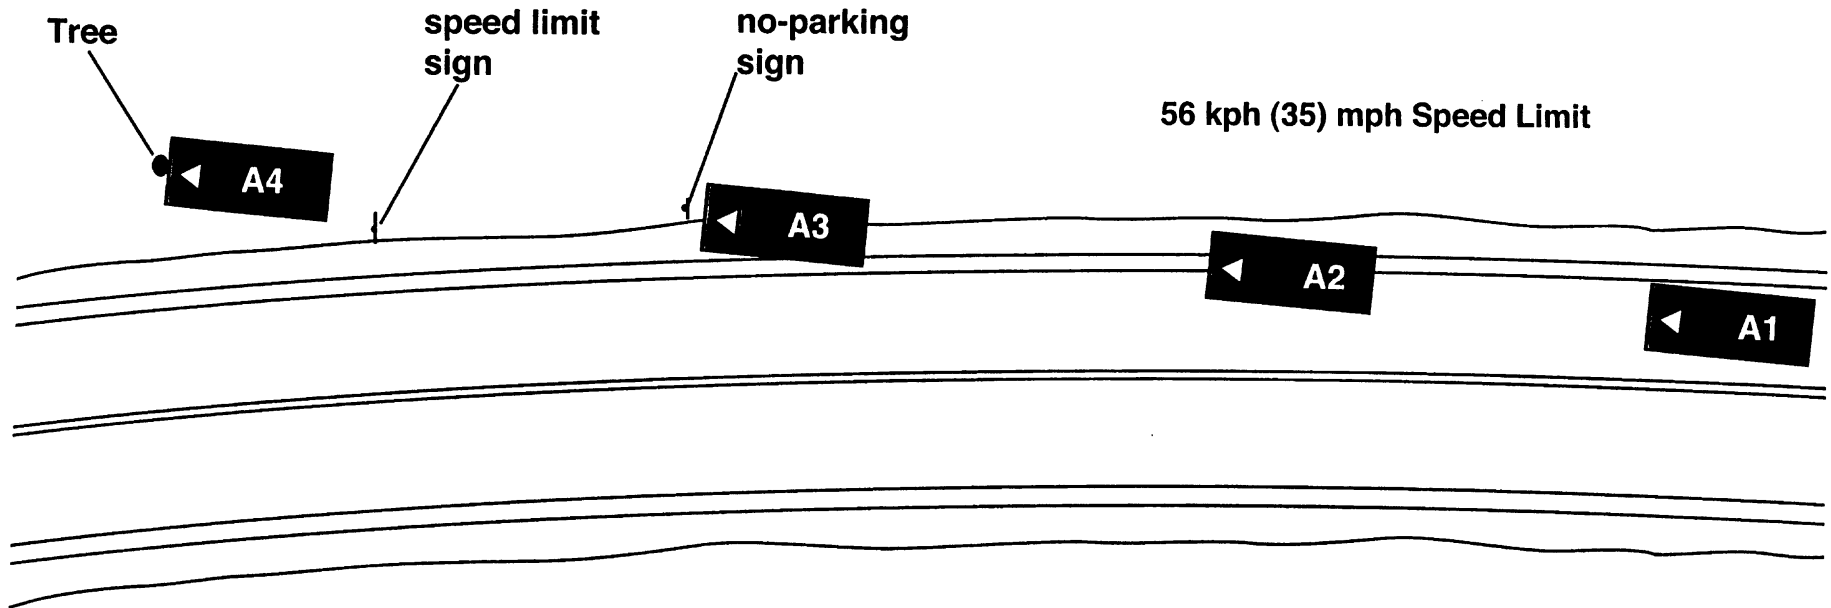
ACCIDENT SCHEMATIC

ACCIDENT DESCRIPTION: Case vehicle (A) was traveling in the westbound lane of a two-lane roadway, negotiating a left sweeping curve. The driver of case vehicle (A) reportedly fell asleep and departed the road off the right shoulder and drove over one traffic sign and sideswiped another. The driver of case vehicle (A) reportedly awoke just prior to striking a tree and attempted to avoid the collision by braking, but struck the tree with the front of case vehicle (A)

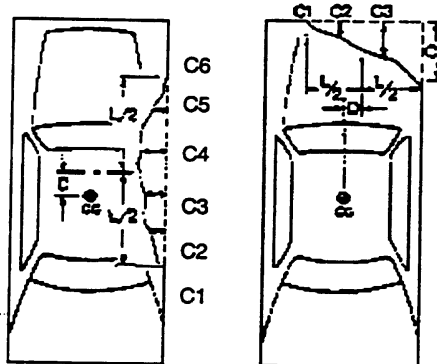
Specific Impact No.	Location of Direct Damage	Location of Field L
1	Ends-36cm from (R) bumper corner	B.C. to B.C.

DL 26
UDL 109

(Slide 3) Damage to case vehicle (A) was moderate and was primarily to the center of the front end. The direct-damage length from the impact with the tree was 26 cm and began 36-cm inboard from the right-front bumper. The maximum crush to the bumper was 45 cm and occurred 43-cm inboard from the right-front bumper corner. The left wheelbase was extended 6 cm, and there was no significant change in the right wheelbase. The sideswipe damage from the sign began approximately 20-cm rearward from the left-front axle and ended approximately 15 rearward of the left-rear axle. There was no significant crush resulting from this sideswipe.

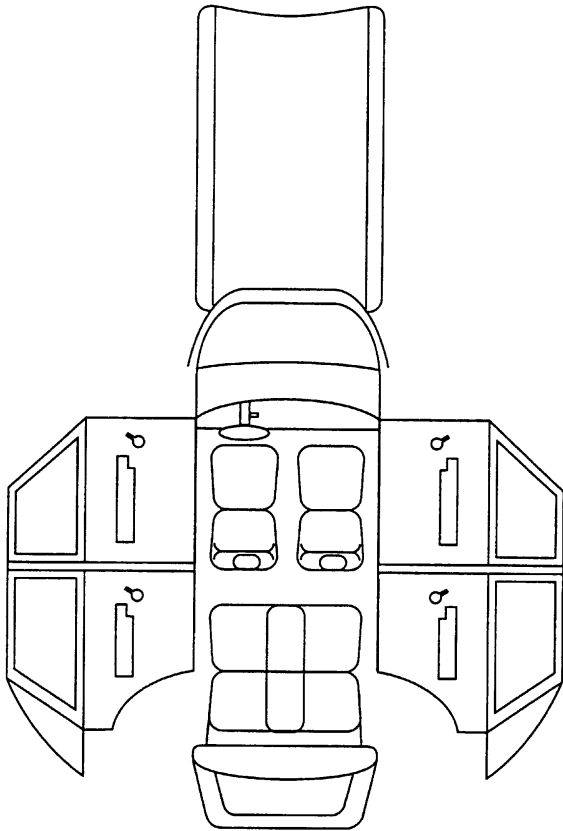
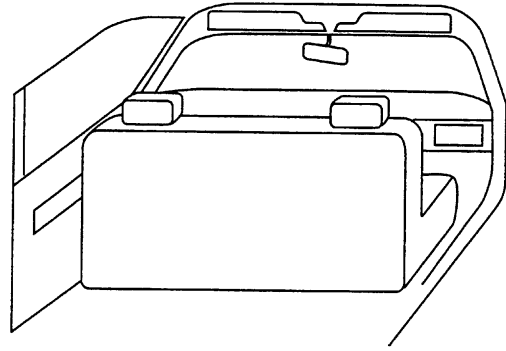
**Exterior damage to
windshield**

**Airbag cover
damage**

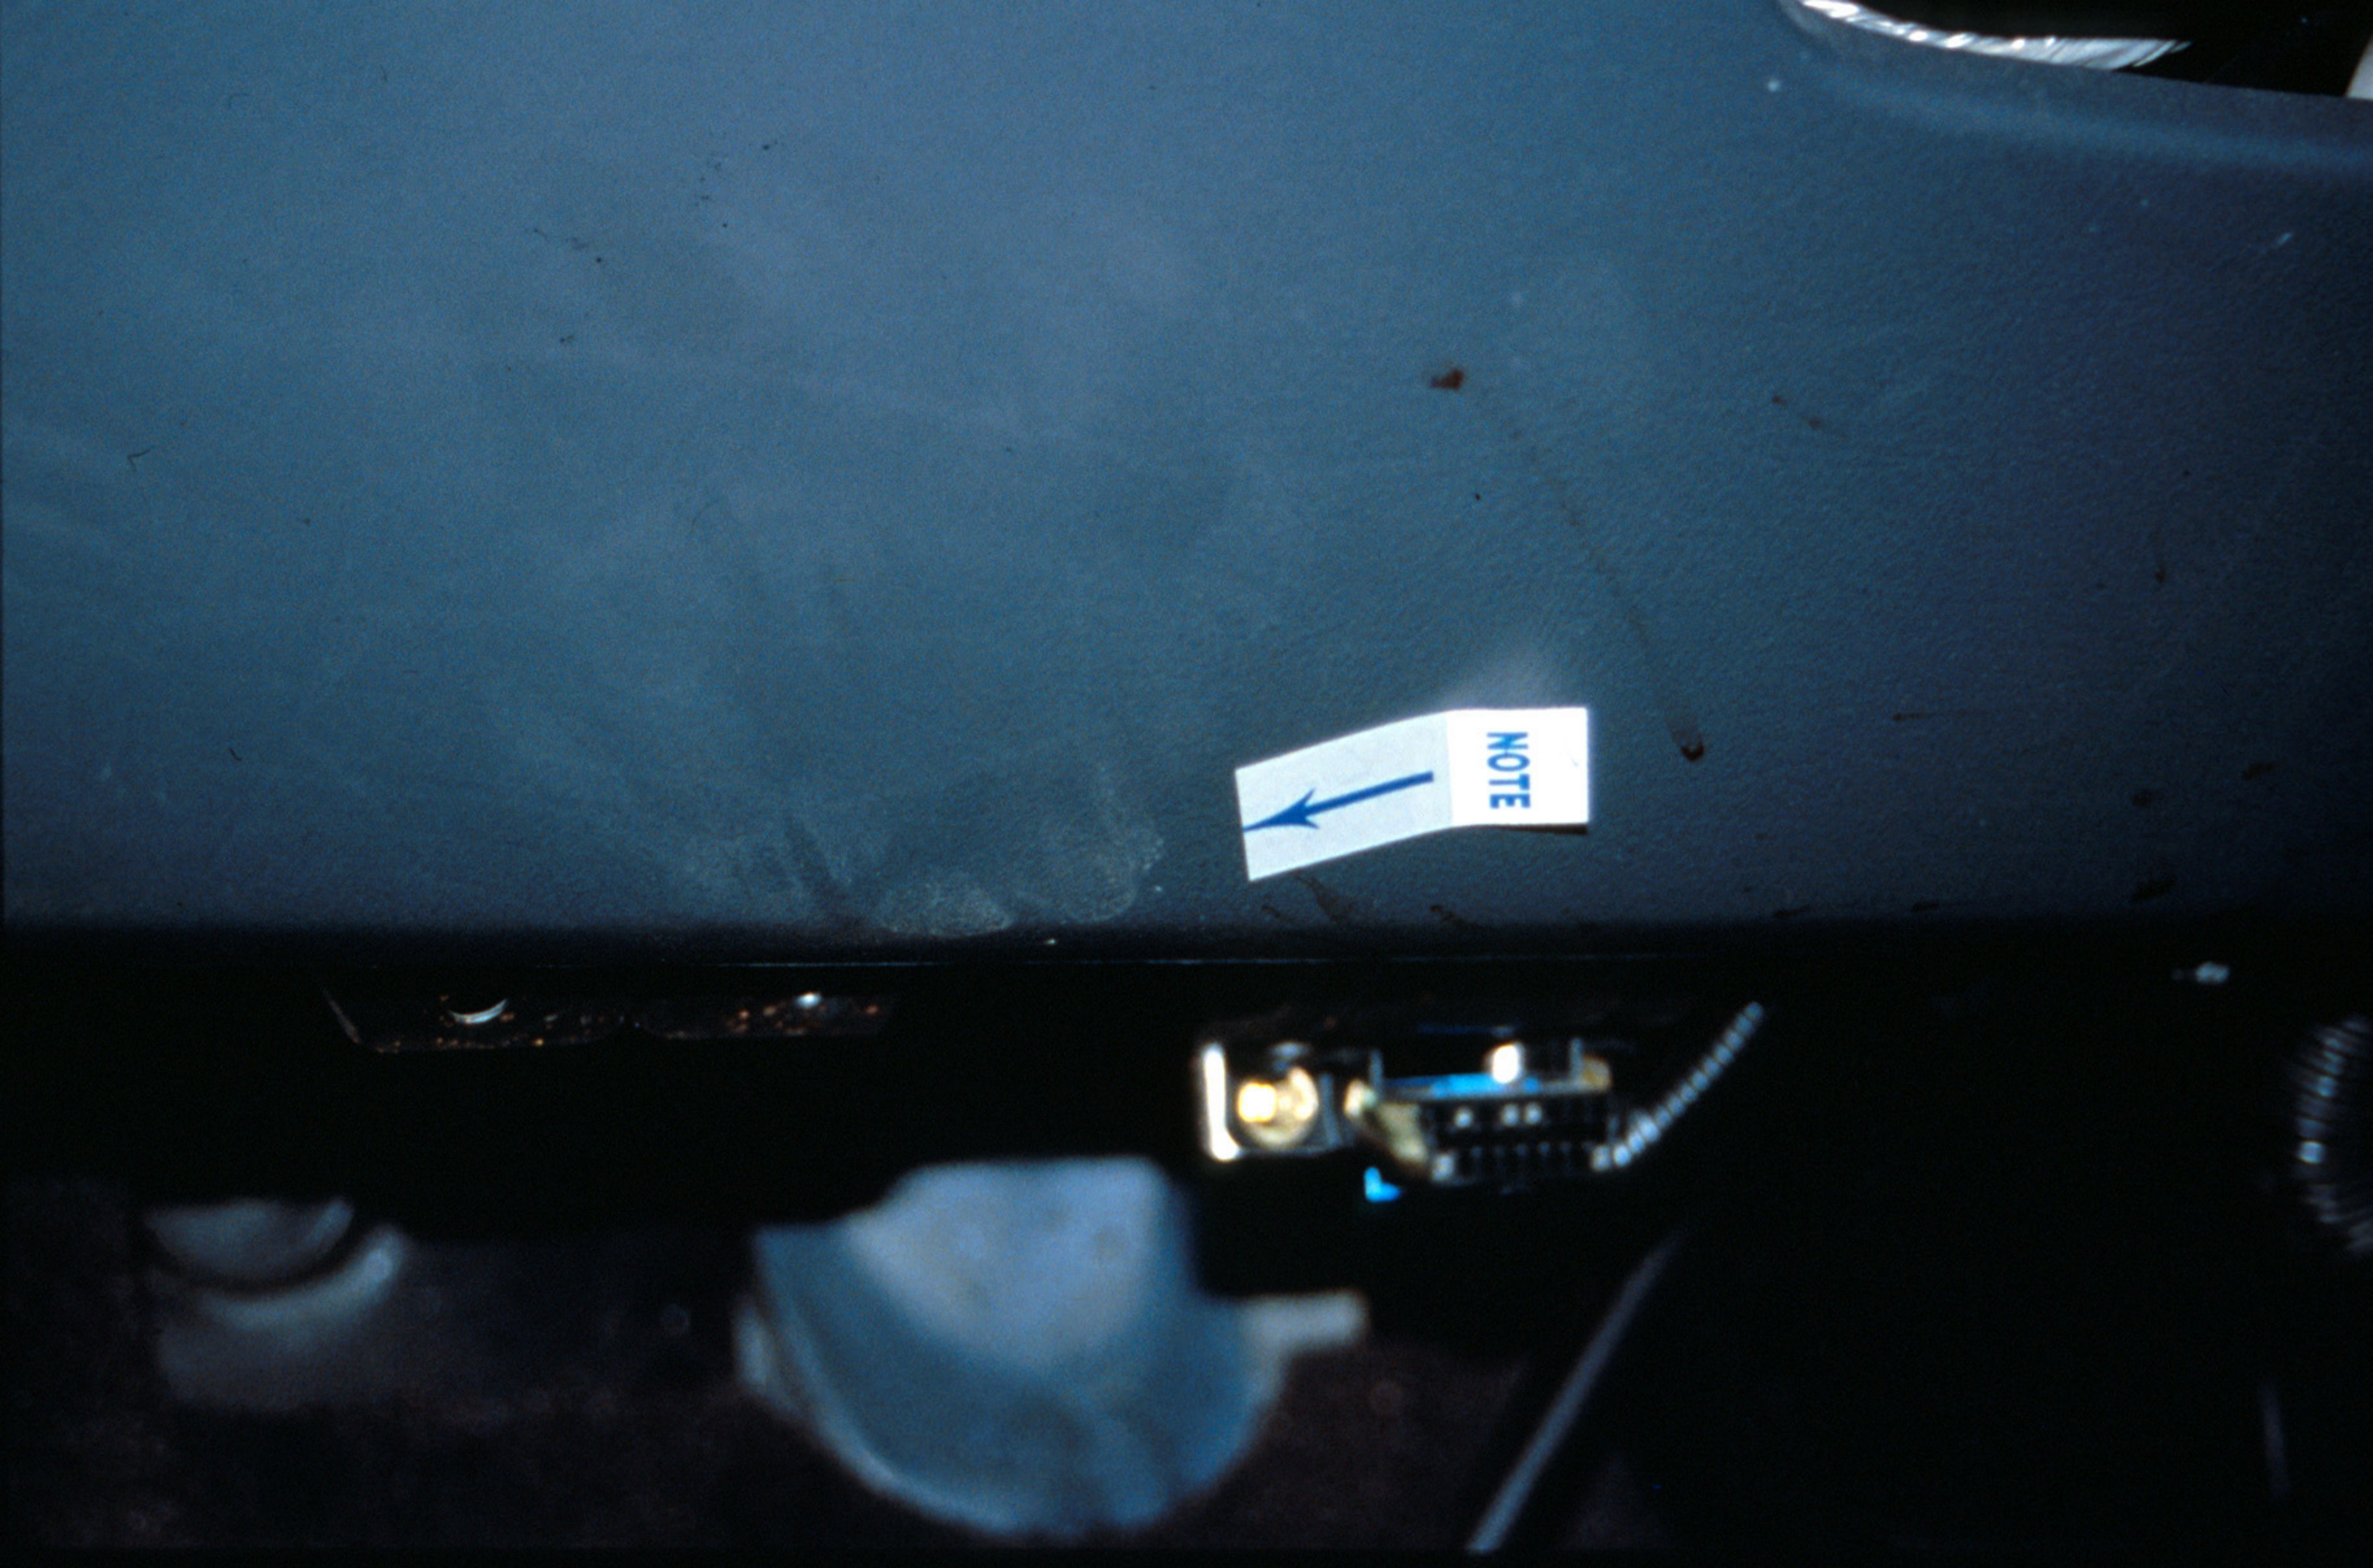
PN 21200#42

(slides 40, 41, 42, 43, 44) scuff marks were noted on the driver knee bolster and the left side of the vertical console.

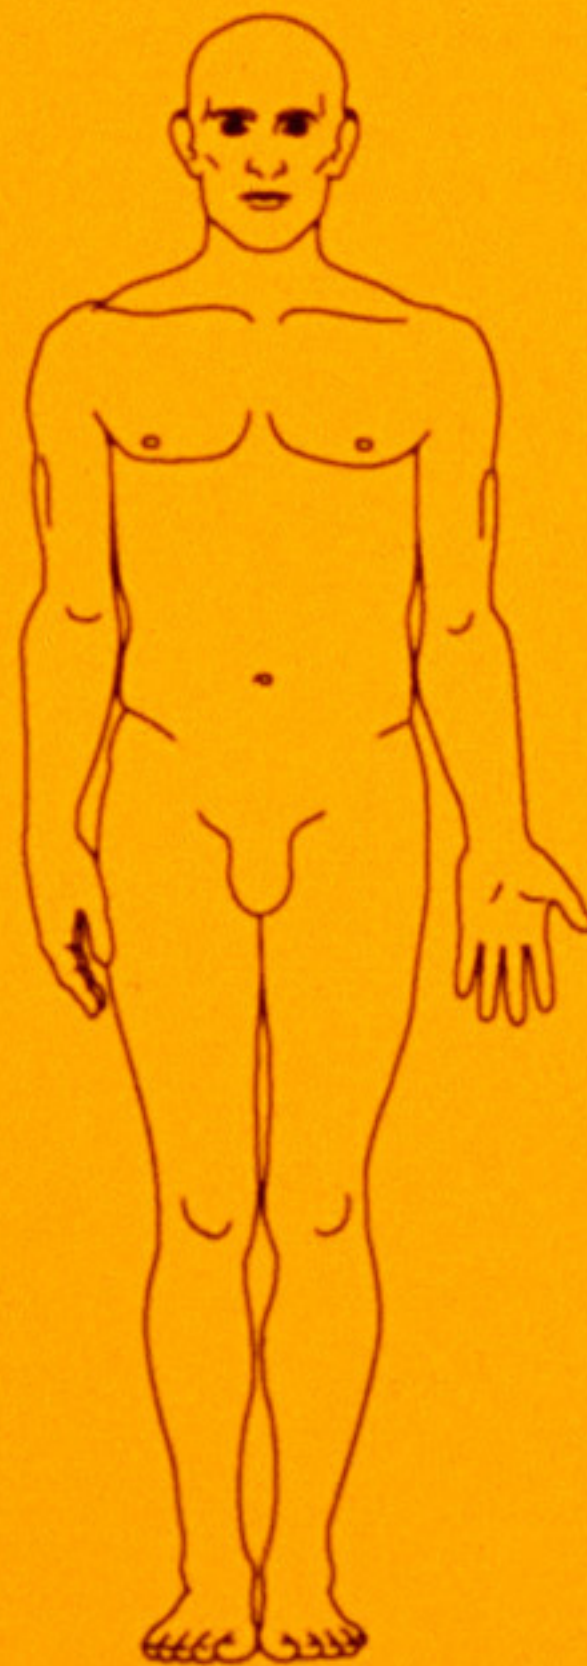
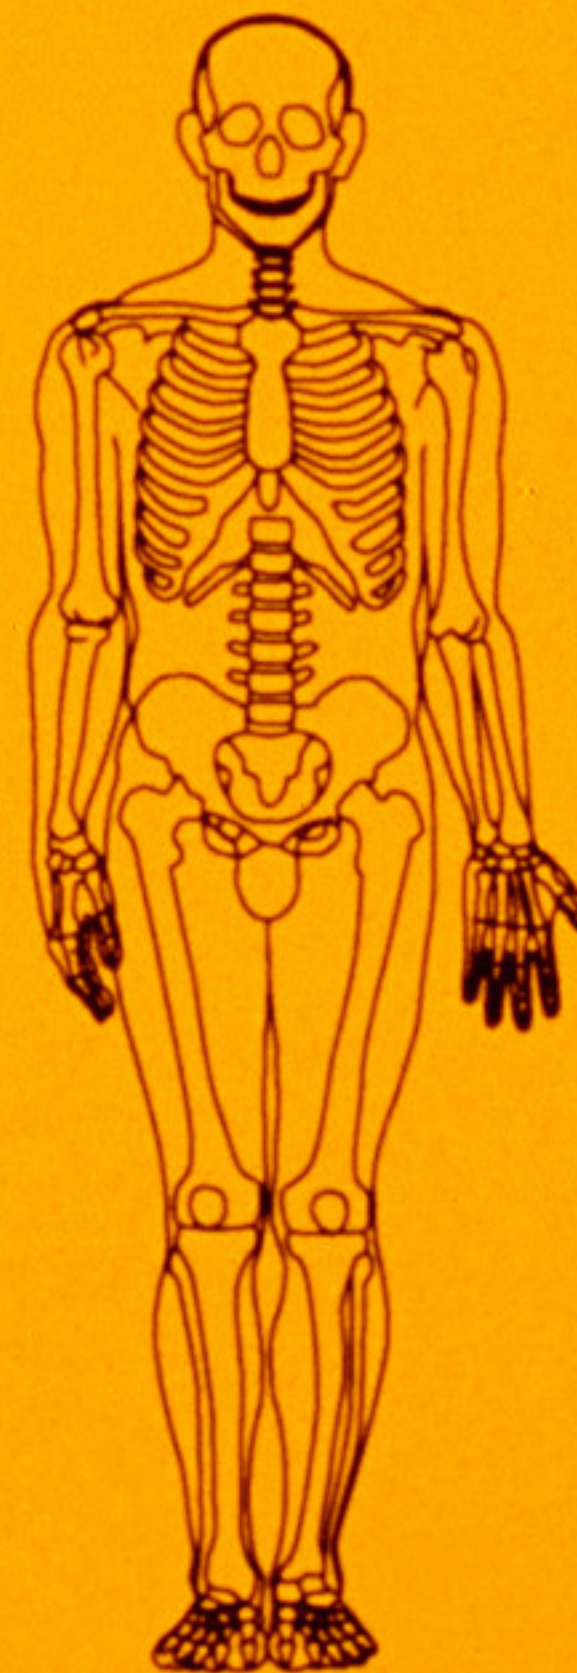
RESTRAINTS: 3-point belt worn; airbag deployed

SEVERITY: MAIS - 0 ISS - 0

No Injury Reported

The following table and (slide 45) attached drawing summarize the injuries sustained by the driver.
